SOUTH DOCK MARINA HEALTH & SAFETY PROJECT

The Proposal

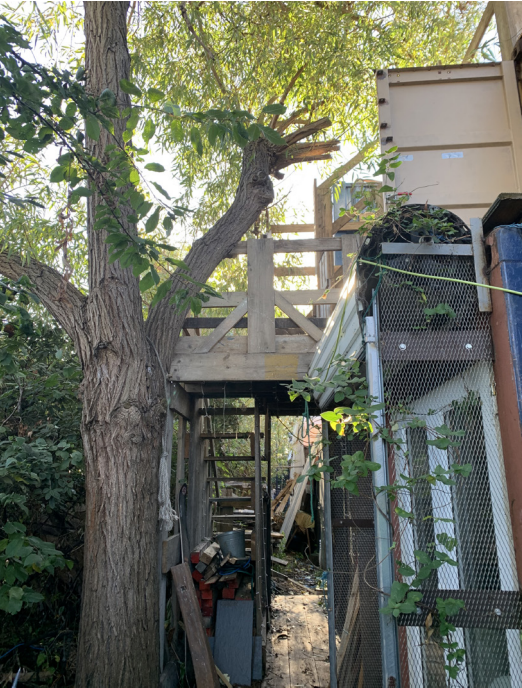
1. UNSAFE ACCESS / ESCAPE
Access to a number of the containers / units is from the rear either via or adjacent to zones of soft landscaping or unmade ground. The access to the units is unsuitable as the access is very narrow and not of solid made ground in various places. A number of containers are located at first floor level with ad hoc stair access that does not comply with building regulations.

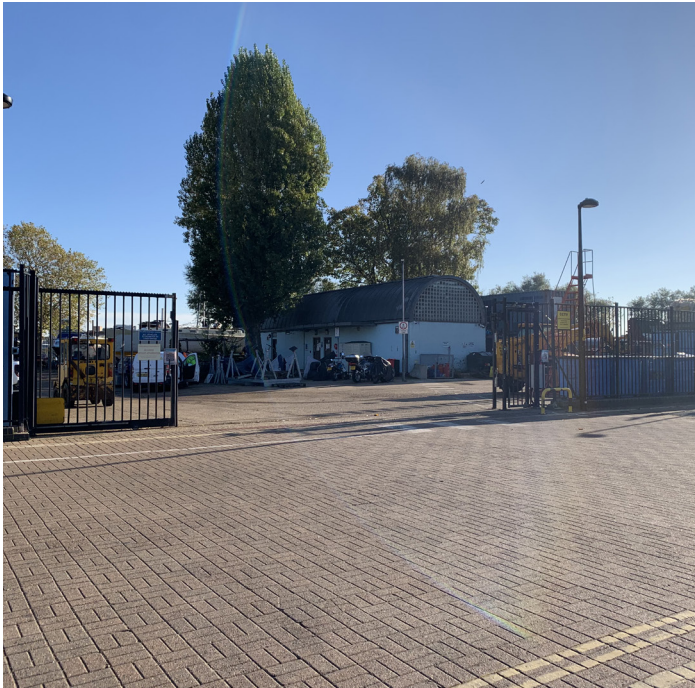
2. PEDESTRIAN & VEHICULAR CONFLICT/ ESCAPE ROUTE
There are no clear routes between vehicles and pedestrians at the entrance. There needs to be clear separation so as to avoid conflict and prevent potential accidents. The only escape route from the boatyard in case of emergency or fire is from the front entrance vehicular and pedestrian gates. Alternative escape routes should be evaluated and considered as part of the proposals.

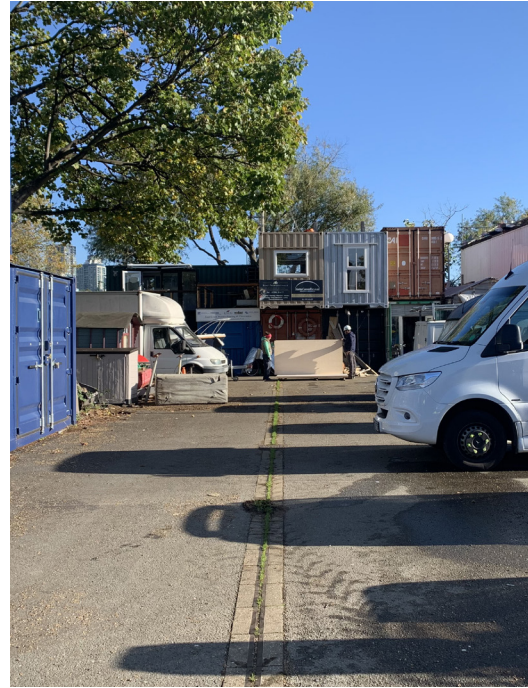
3. INSUFFICIENT DRAINAGE
There are areas of the boatyard where this currently insufficient surface water drainage. This is particularly obvious to areas in the middle of the boatyard where there is ponding, drainage channels that are completely blocked and heavy vehicles have degraded areas of tarmac.

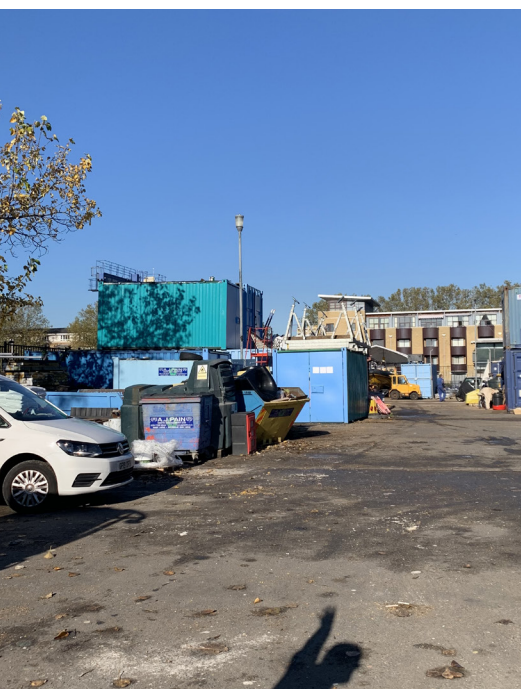
4. EXISTING GROUND SUBSIDENCE
There is significant ground subsidence to the area shown dotted red on the plan adjacent. It is intended that a significant part of this area be used for the storage of heavy boats for which the area is currently not suitable for. This area will be required to be upgraded for the intended use.

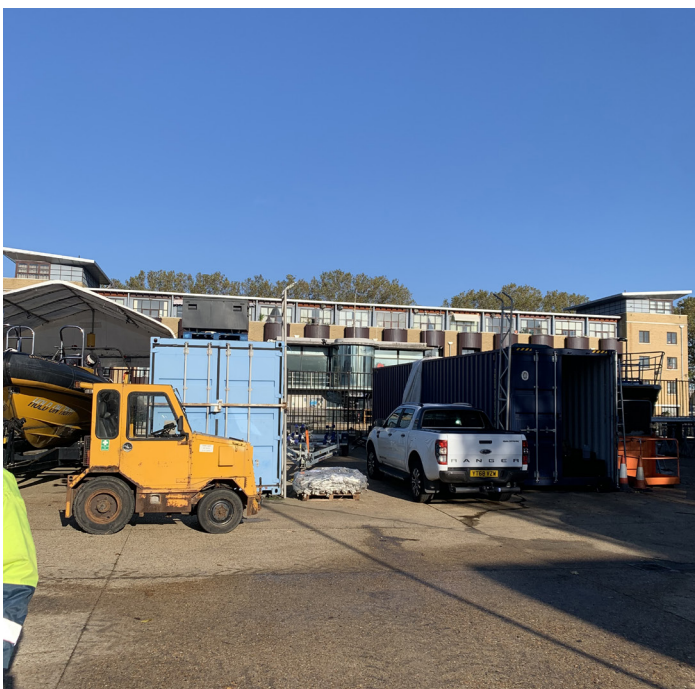
5. WORKSHOP ON MAIN VEHICULAR ROUTE
There is a workshop adjacent to the existing amenity building that opens onto the main vehicular route during working hours that is a safety issue.

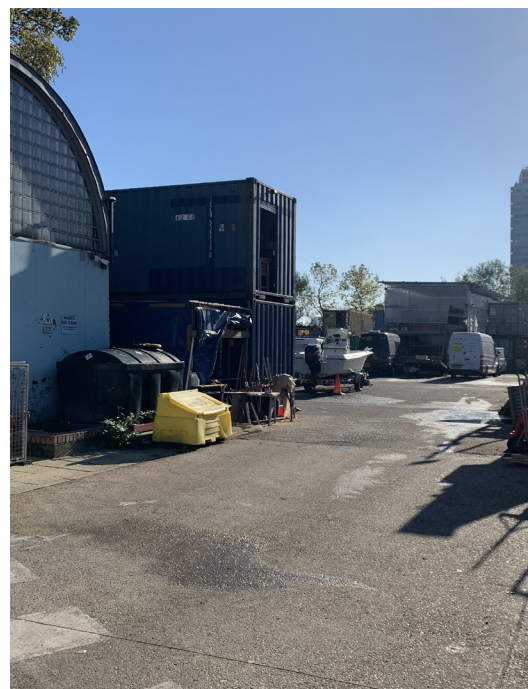
6. CONGESTED ACCESS
The area close to the entrance adjacent to the amenity block is congested and it is difficult to manoeuvre through into the main boatyard area. This area should be reorganised to provide better access.
